Case Study: Lipari Landfill, New Jersey

Lipari Landfill (New Jersey) was plagued by oxidizer maintenance and performance problems. The efficiency of their five year old SVE/oxidation system had dropped by 50%. Lipari Landfill wanted to repair their current system, train operations staff and maintain their equipment on an ongoing basis.

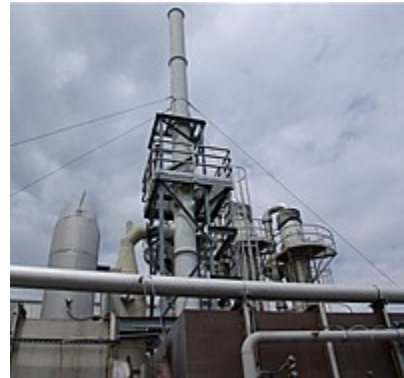
- The oxidizer's high efficiency heat exchanger had been damaged beyond repair during a high temperature event in 2004 and the replacement heat exchanger needed to be protected.
- The vacuum extraction system was transferring excessive amounts of water to the oxidizer.
- The burner needed adjustments and the instrumentation needed to be inspected. Some instrumentation needed replacing.

Our first priority was to prevent repeat damage to the heat exchanger, which had been replaced by the original equipment provider. Because the Lipari oxidizer is treating chlorinated contaminants, the operating temperature is between 1600 - 1750 degrees F as opposed to a traditional thermal oxidizer which runs at 1400 degrees F. Intellishare designed a tertiary air cooling system and reworked existing ductwork to minimize thermal effects of the high temperature application on the heat exchanger.

temperatures) when water transfer is eliminated. Intellishare replaced the existing water removal system by using a primary 'surge tank' in combination with a secondary vessel for mist elimination. The surge tank was designed to fit in an existing below grade vault and the vapor liquid separator was placed above grade.

- Redesign and repair of existing thermal oxidizer, VLS & scrubber
- Design and construction of new water separation system
- Re-engineered cooling air injection system
- Redesign instrumentation and control system
- Staff operator training
- Long-term maintenance agreement
